Illinois Commerce Commission
Assessment of Mt. Carmel Public Utility Company's
Reliability Report and Reliability Performance
for Calendar Year 2002

Pursuant to 83 Ill. Adm. Code 411.140

August 13, 2003

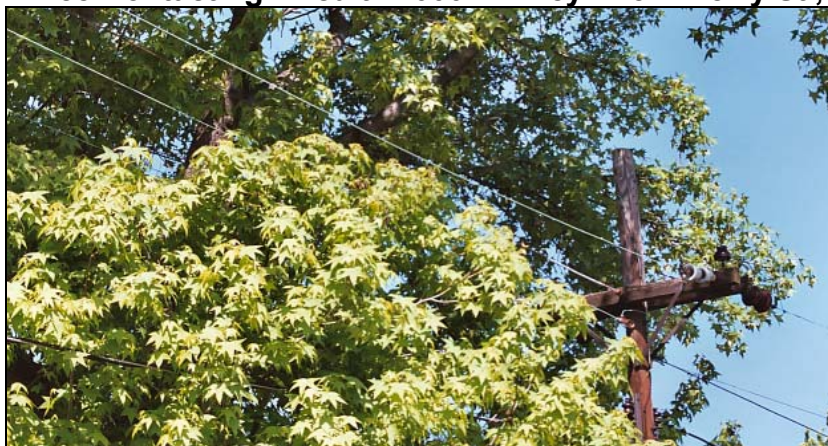
Figure 1
Sweet Gum Tree Contacting Circuit 22000 in Alley E. of Cherry St., Mt. Carmel

- A) Mt. Carmel should implement the tree trimming plan it is investigating, "to begin circuit wide tree trimming with a projected return schedule of three years." The plan should include written documentation of its tree trimming policy, a written schedule for trimming each of its circuits, and records to document when tree trimming was last completed on each circuit. The tree trimming policy should include a requirement that trees be trimmed such that, as a minimum, they not make contact with Mt. Carmel's electric facilities before crews return to trim them again.

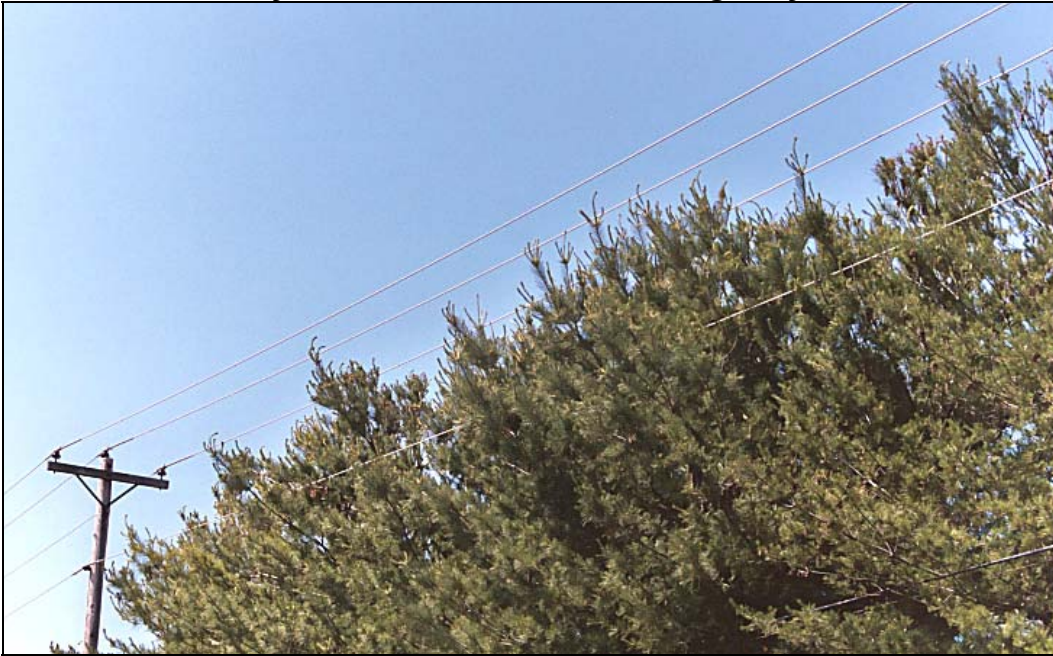
Figure 2
Pine Trees Very Close to Circuit 22000 on Highway 1, Mt. Carmel

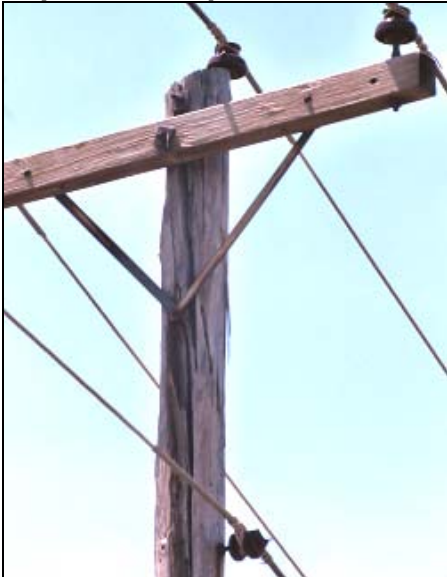
Figure 3
Split Pole Top, Circuit 22000

- C) Mt. Carmel should investigate all of the problems noted during Staff's inspections of worst-performing circuits (see Attachments A, B, and C) and take appropriate remedial actions addressing any problems on those circuits, whether or not noted by Staff, which can significantly affect service reliability or public safety.

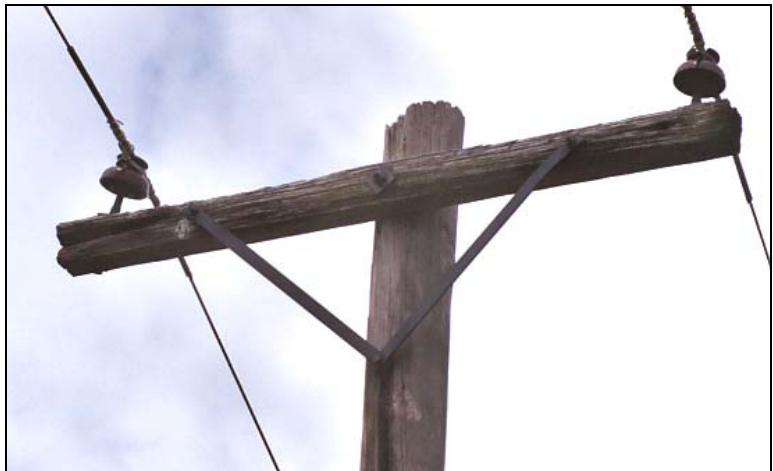
Figure 4
Split & Deteriorated Crossarm, Circuit 22000

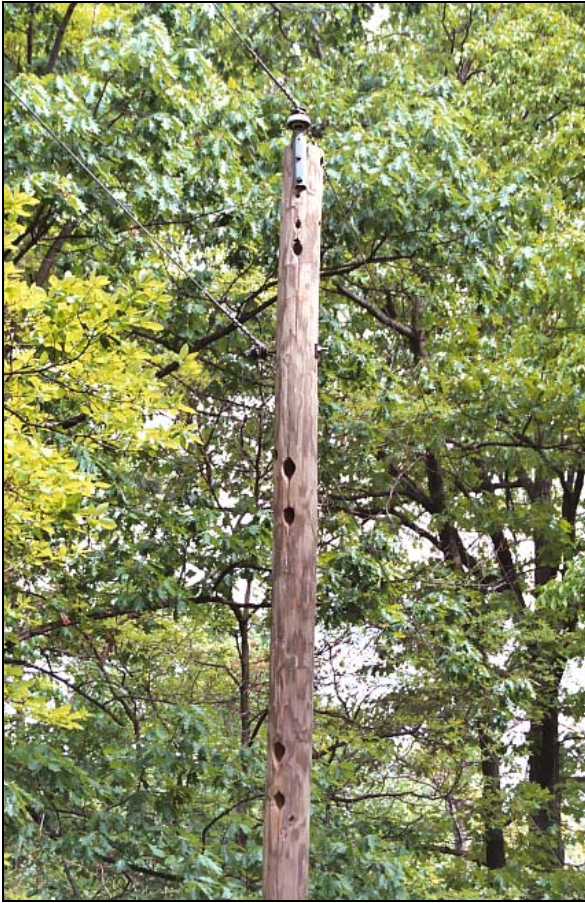
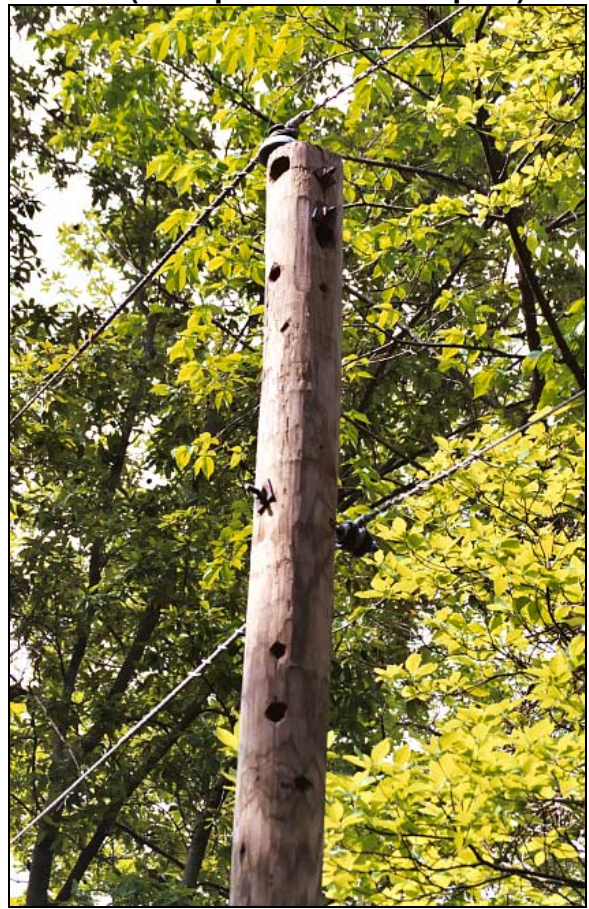
Figure 6

Figure 5
15 Woodpecker Holes in Pole, NW of Mesa Lake (both photos of same pole)

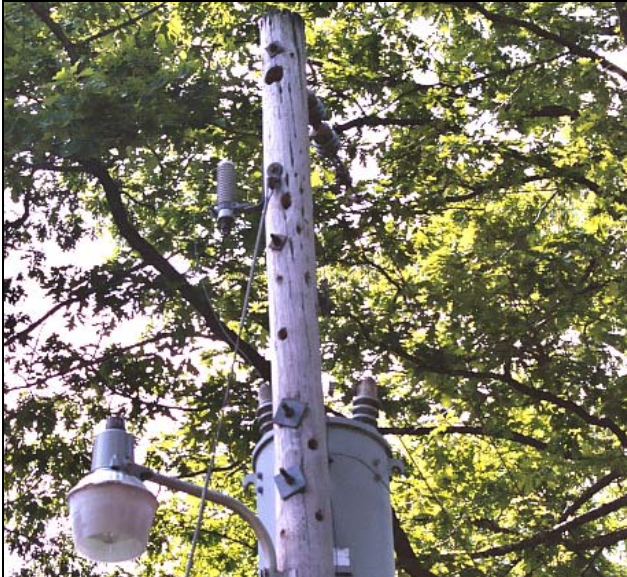
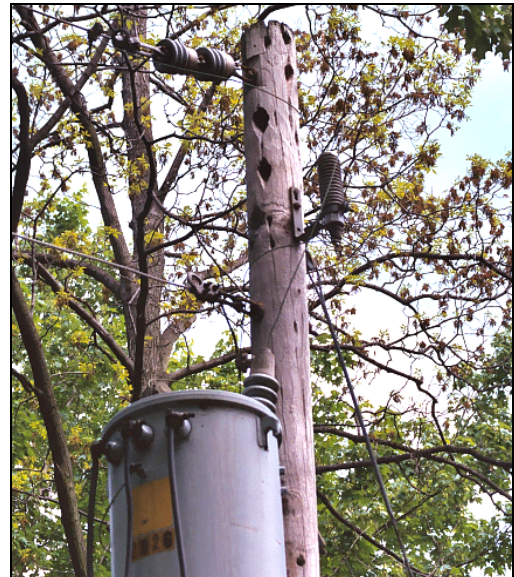
Figure 8

Figure 7
11(+) Woodpecker Holes in Pole, NW of Mesa Lake (both photos of same pole)

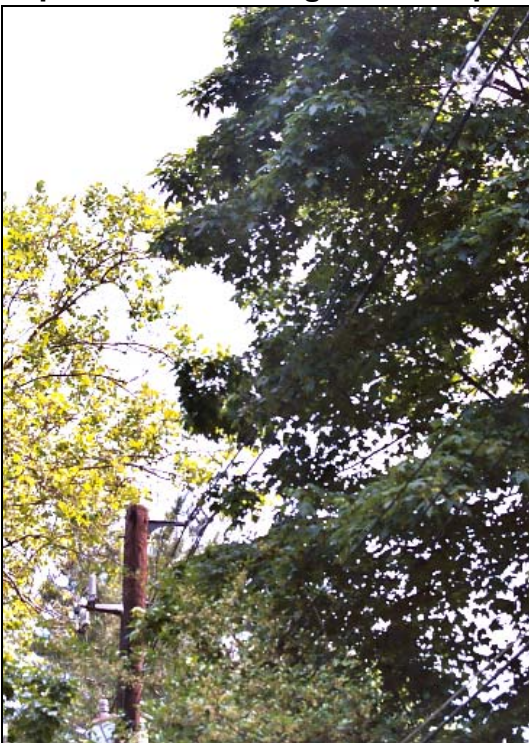
Figure 9 (Circuit 12000, Mt. Carmel)
Spacer Cable through Hard Maple

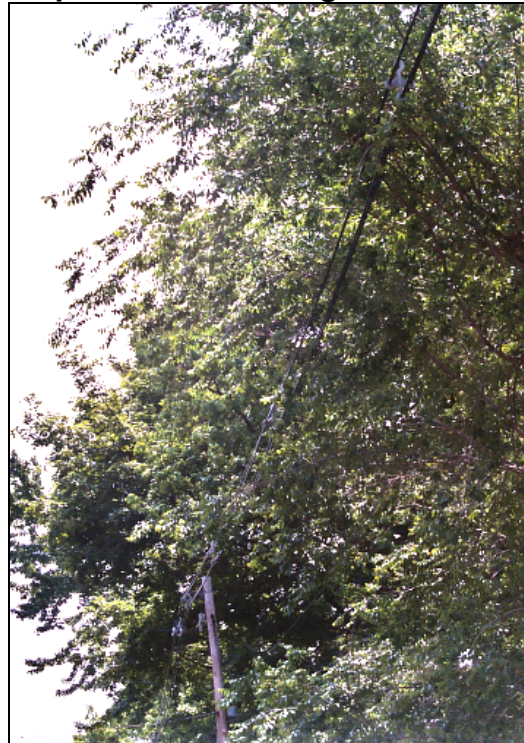
Figure 10
Spacer Cable through Elm Tree

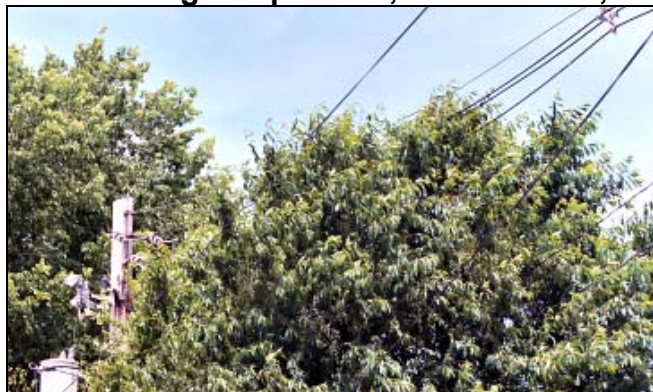
Figure 11
Spacer Cable through Maple Tree, Circuit 12000, Mt. Carmel

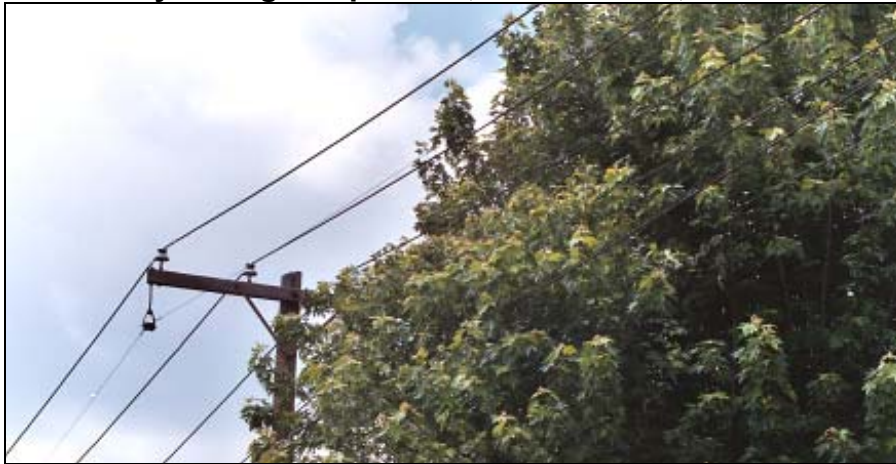
Figure 12
Primary through Maple Tree, Circuit 13000, Mt. Carmel

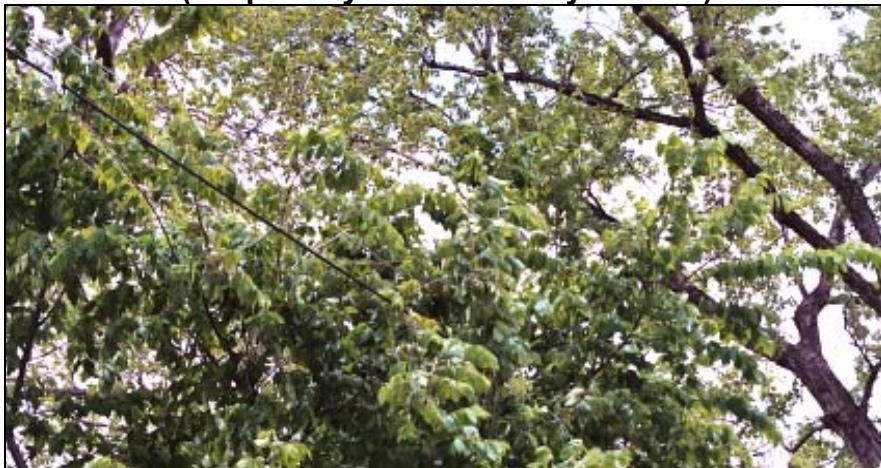
Figure 13
Single-phase Spacer Cable through Mulberry Tree, Circuit 13000, Mt. Carmel
(the primary is deflected by the tree)

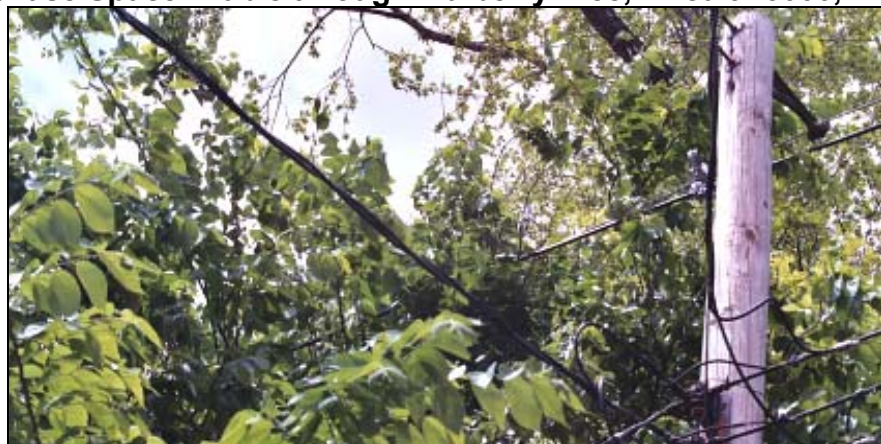
Figure 14
Single-phase Spacer Cable through Mulberry Tree, Circuit 13000, Mt. Carmel
